Immingham Jetty Inspection

Frankham were appointed to carry out a structural inspection on a jetty on the River Humber

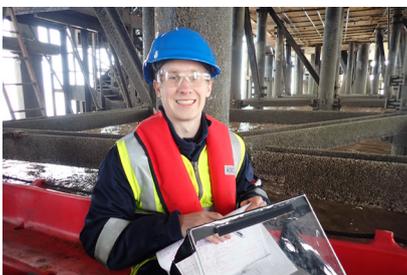
Our engineers discovered accelerated low water corrosion (ALWC) or microbially influenced corrosion (MIC) on some steel piles during inspections. ALWC is lesser known phenomenon which can cause catastrophic damage if left unchecked and Frankham take opportunities to raise awareness of this defect where we can.

MIC is best identified by visual inspection; giveaway signs include bright orange corrosion over a black film material which if you scrape away will reveal shiny pitted steel beneath as pictured. Spotting these tell-tale signs can be difficult as they are sometimes obstructed by marine growth, so it's important to remove as much marine growth as possible during inspections.

Remedial strategies are driven by the extent of damage caused. Low damaged areas can be protected by cathodic protection systems or coating whereas highly damaged areas may require local plate repairs in addition to protection.
