BISHOPSGATE GOODS YARD

INVESTIGATE OUTLINE STRENGTHENING OPTIONS

Frankham Consultancy Group were appointed to investigate outline strengthening options for mitigating the deteriorating condition of a brickwork Jack Arch deck at Bishopsgate Goods Yard.

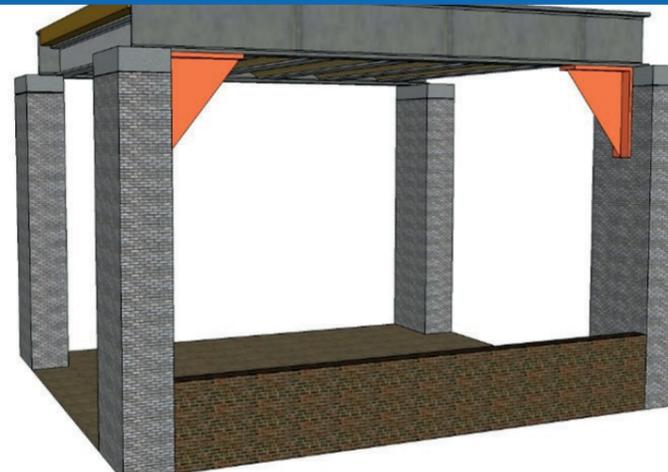
Fig. 2: Schematic sketch of the support bracket strengthening option.

Information collected from the surveys and investigations guided the outline design proposals for the strengthening support works. Several options were identified as potential solutions, which included a mixture of new girders, support brackets and columns depending on defects and constraints present. Each option was appraised and a method on construction provided, with the preferred design recommended.

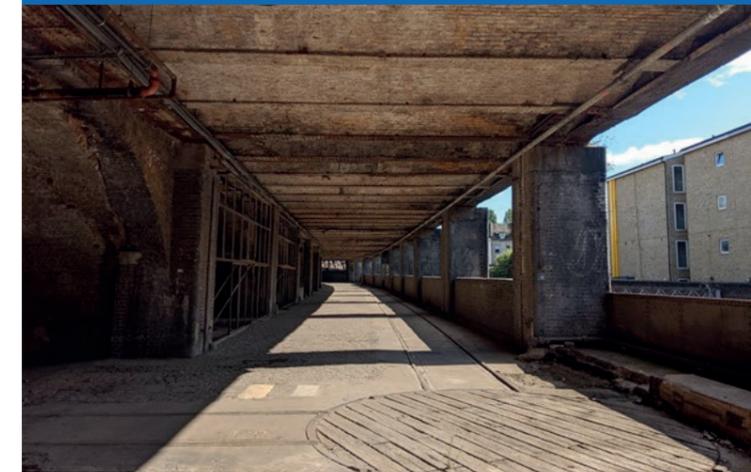
Fig. 3: View down deck level of viaduct.

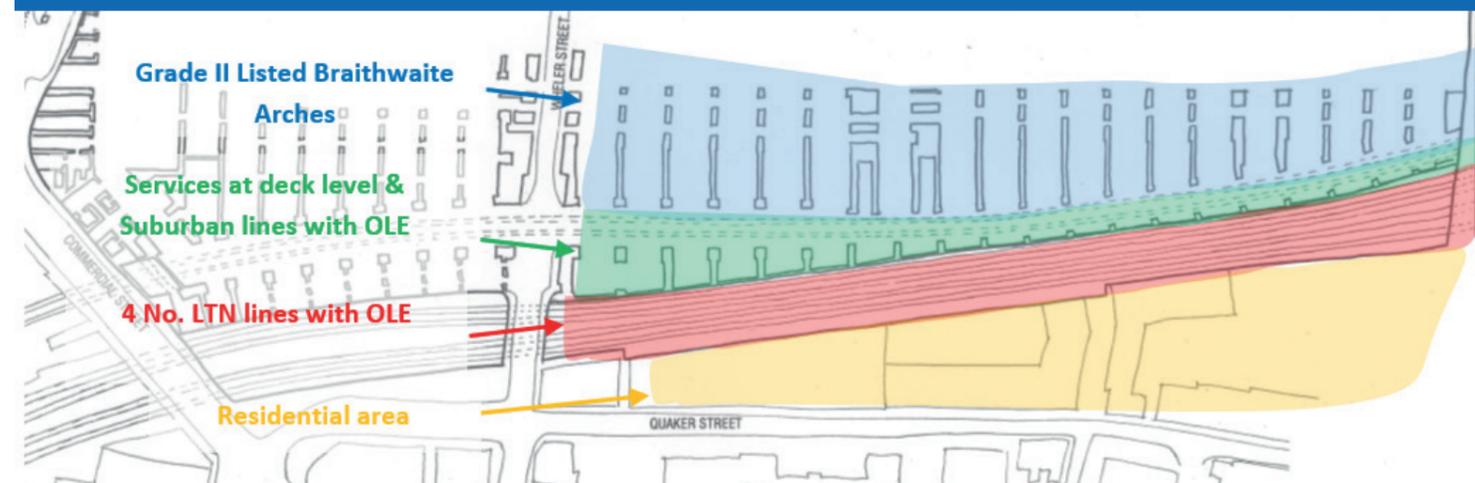
Fig. 4: Some of the site constraints identified that would influence the strengthening works

As part of the initial study, Frankham undertook a detailed desk study and site visit to identify the constraints that may influence or affect the strengthening designs, including details review of the previous structural assessment report.
