CATFORD UTX

NETWORK RAIL – SOUTHERN REGION

NEW UNDERTRACK TRACK CROSSING

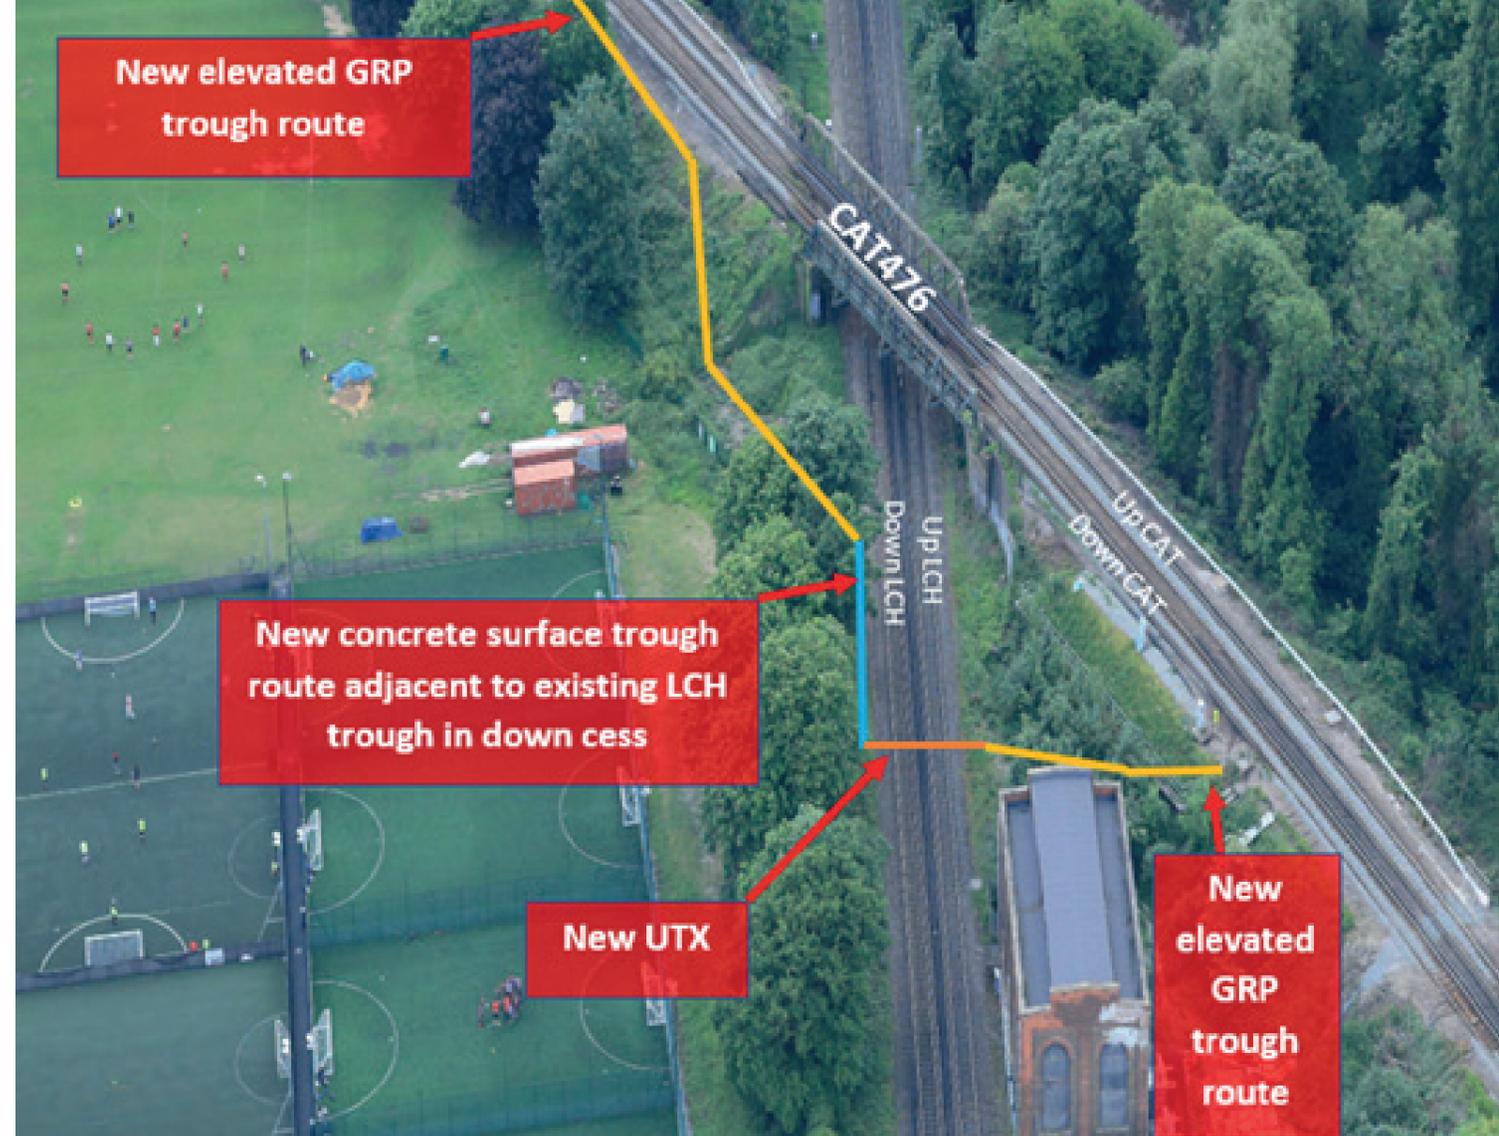
Fig. 1 New route for existing services being diverted prior to replacement of intersection bridge.

Due to the reconstruction of intersection bridge CAT 476, Frankham Consultancy Group were appointed to carry out the design of a new Undertrack Track Crossing (UTX) crossing and elevated trough route to permanently divert existing service cables.

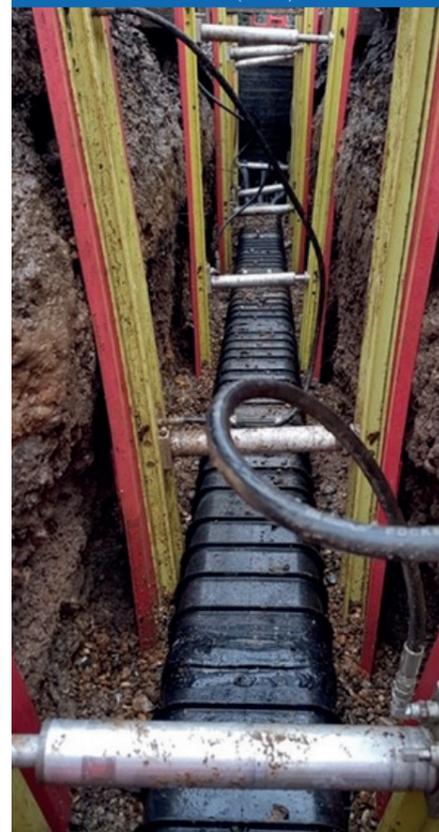
Fig. 2 Installation of temporary works, duct and turning chamber (at rear).

Due to constraints dictated by the standard and site, it was not possible to install the UTX using benching or battering. Temporary works were instead utilised to achieve the open cut installation method using a proprietary system (Fig. 2). The new UTX passes from cess to cess and connects to new inspection chambers to allow several cables to be carried.

Due to the constraints imposed by the site and surrounding environment, such as limited possessions and buried services, High-Density Polyethylene (HDPE) chambers and ducts were used to form the UTX to allow for speed and flexibility in the installation.

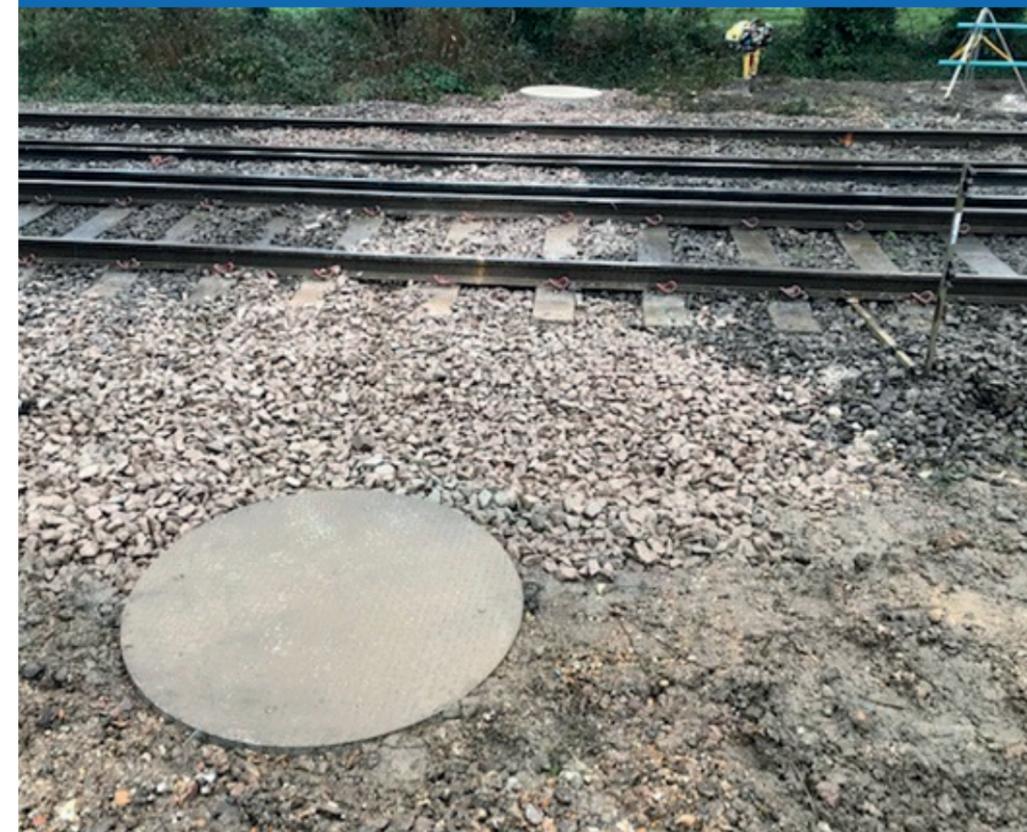
Fig. 3 Completion of works and reinstatement of tracks and ballast.
